Manhole Inspection Summary

Manhole # S13AA_016MH

Location Address: **REAR OF 2843 LAFAYETTE AVE** Cross Street: **POPLAR GROVE ST**

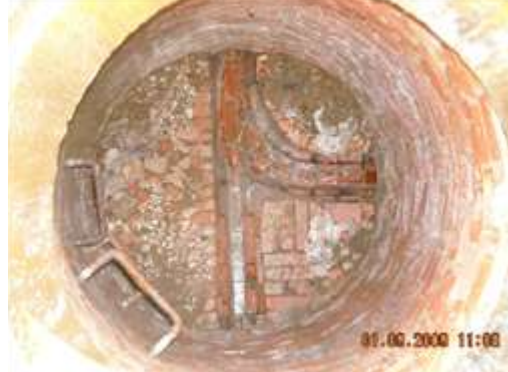
Top View

SHEETING

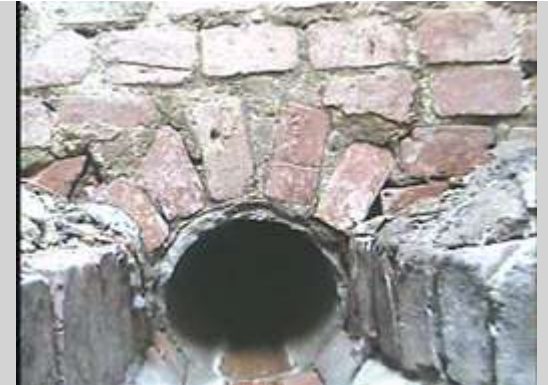
12 O'Clock Outflow

8 in. Circular Gravity Sewer
Pipe Out @ 12 O'Clock

Pipe Height: **8.4** (in.) Rod and Bar (Angled)
Pipe Material: **Clay** ☐ Pipe Lined
Invert Depth: **7.30** (ft.) Flow Characteristics: **Slow**
Deposits: ☒ None ☐ Mud ☐ Sludge ☐ Debris ☐ Grease
Silt Depth: (in.) Deposits Extent:
Infiltration: **None** Pipe Seal Cond: **Sound**

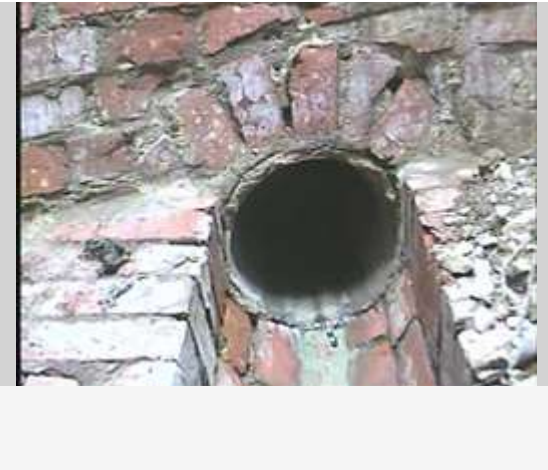
6 O'Clock Inflow

8 in. Circular Gravity Sewer

Pipe In @ 6 O'Clock

Pipe Height: **8.4** (in.) Rod and Bar (Angled)

Pipe Material: **Clay** ☐ Pipe Lined

Infiltration: **None**
